Water resource evaluation for Udaipur district

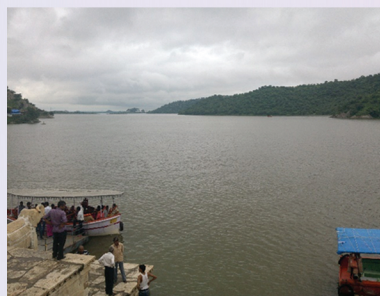
Jaisamand Reservoir (Major source of water in the district)

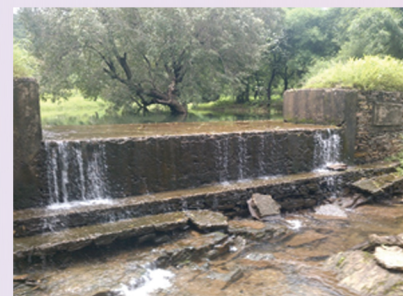
Checkdam at Kunda Village (Evaluation of Existing structures)

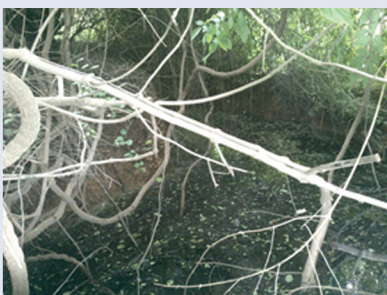
Abandoned well at Udaisgar Chaurahi (Rejuvenation Options)

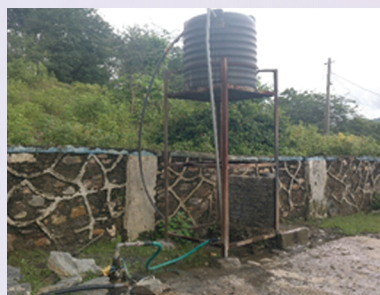
Drinking water supply at Borakheda village (Evaluation of water supply infrastructure)

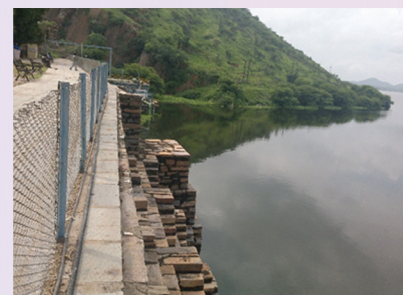
Pumphouse at Picchola Lake (Evaluation of existing drinking water schemes)
